NATIONAL TRANSPORTATION SAFETY BOARD

Cockpit Voice Recorder Study - 12

Specialist's Report By Anna W. Cushman

Location: Jefferson City, Missouri
Date: October 14, 2004, 2215 CDT*
Aircraft: CL-600-2B19, N8396A
Operator: Pinnacle Airlines (d.b.a Northwest Airlink), Flight 3701
NTSB Number: DCA05MA003

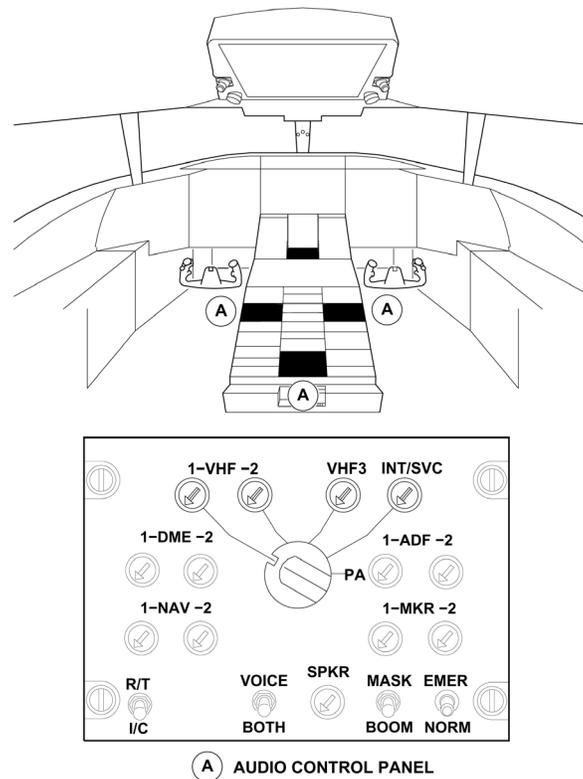
Figure 1: Audio control panel configuration and locations.

Per the aircraft maintenance manual for the CL600-2B19 (N8396A, serial number 7396), the audio/communication system enables crewmember communication (both radio communication and internal crewmember communication) by interfacing several systems, which include the communication transceivers, navigation receivers, aural warning system, passenger address and cabin interphone, CVR, FDR, and service interphone. The audio integrating system components include the audio control panels (see Figure 1), audio-electronic control unit (AECU), speakers, headphone/microphone jacks, and push-to-talk switches. The push-to-talk switches are located on the two control wheels and the three audio control panels. The AECU performs a vital role in the CVR study in that it processes all of the audio inputs and sends the information to the appropriate outputs, including the CVR and FDR (see Figure 2). Specific elements interfacing through the AECU are discussed in the appropriate sections that follow.

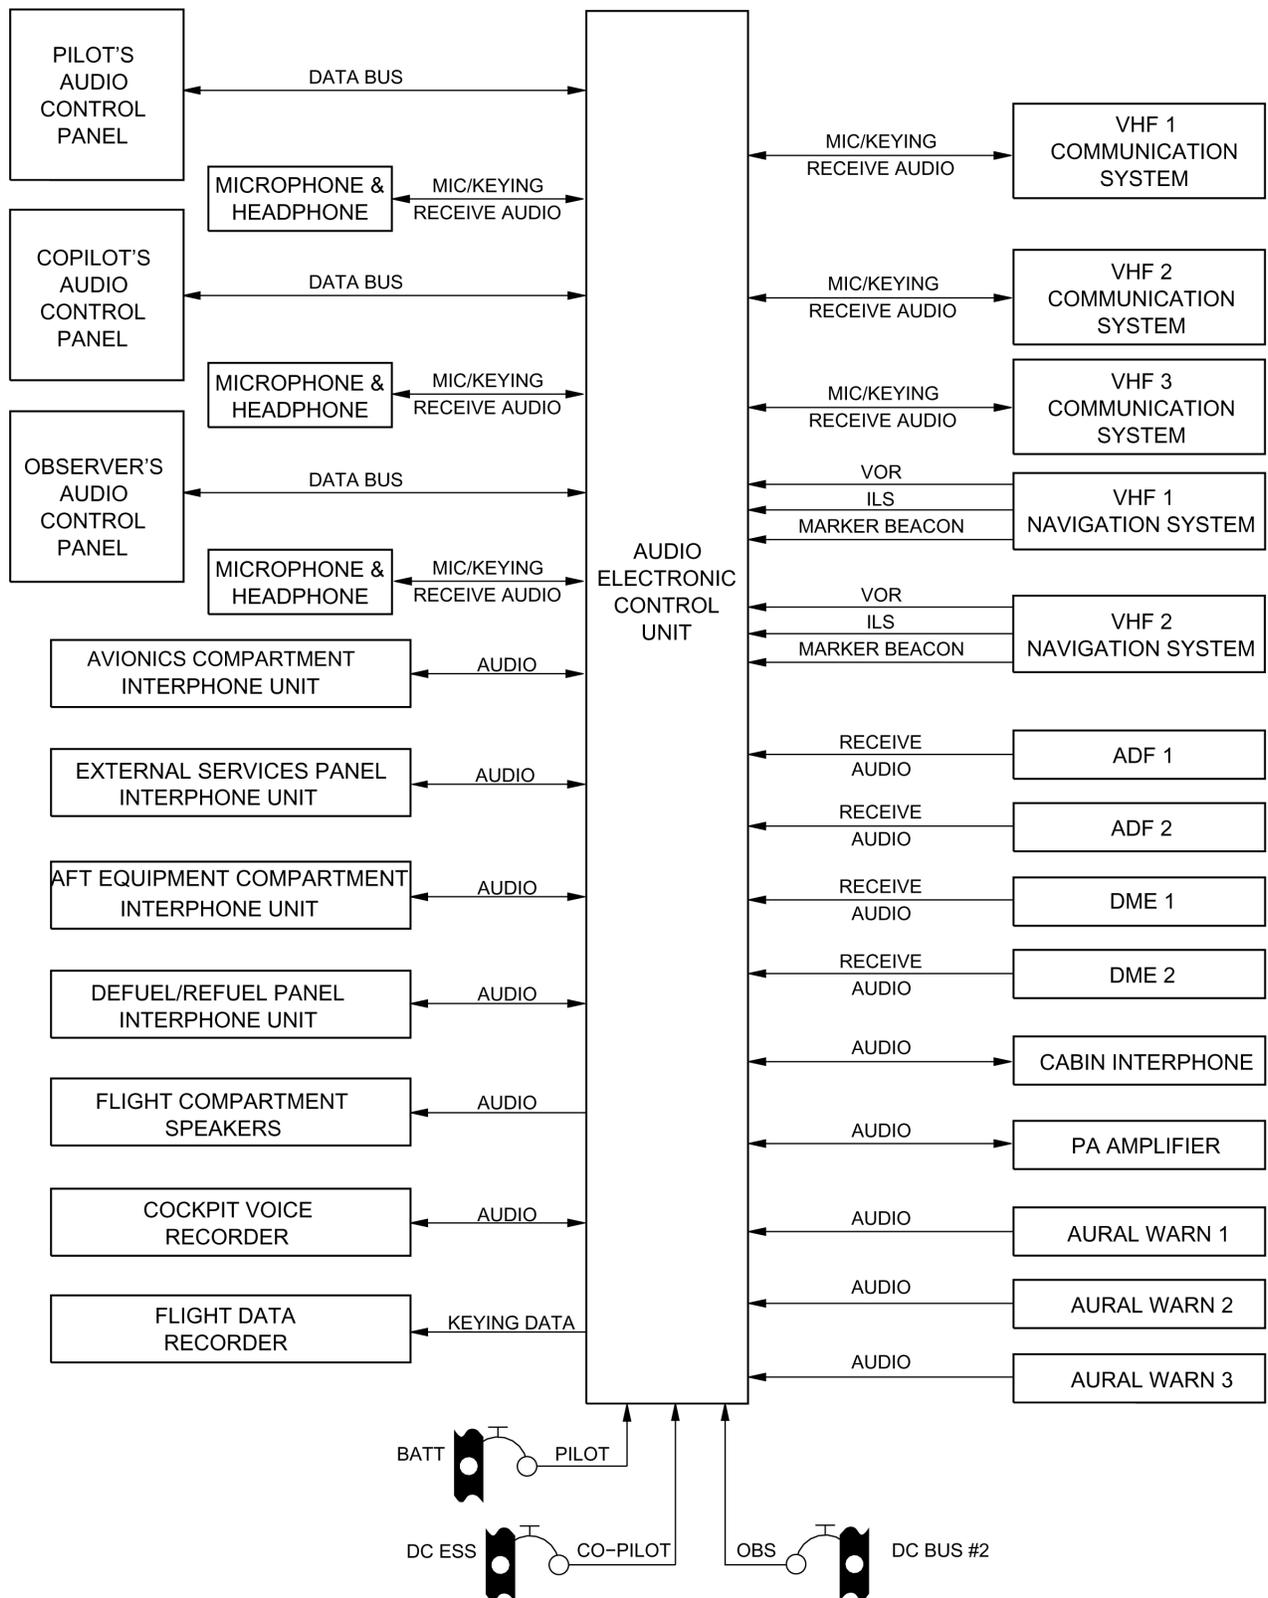
Figure 2: CRJ Aircraft Maintenance Manual, Audio Integrating System - Block Diagram

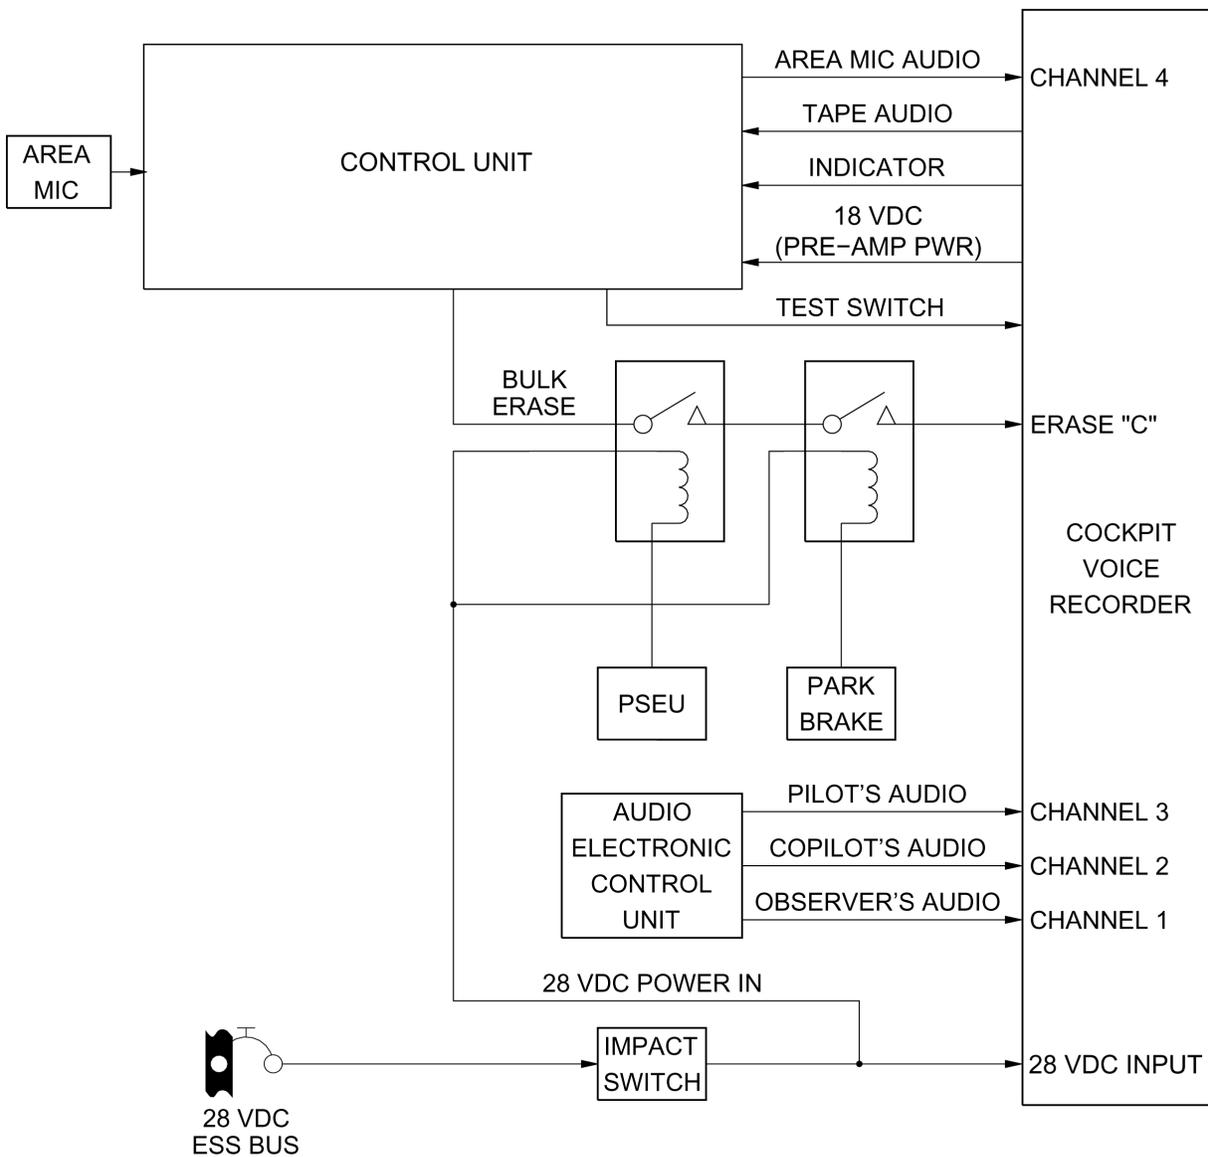
Figure 3: CRJ Aircraft Maintenance Manual, CVR System - Block Diagram

As stated in the CVR Group Chairman's Factual Report, the cockpit voice recorder installed on the accident aircraft was a solid state Fairchild A100S model CVR by L-3 Communications. The CVR is one component in the CVR system on the aircraft. The other components include the control unit, cockpit area microphone (CAM), impact switch and underwater locator beacon. From the aircraft maintenance manual, the CVR control unit contains a TEST switch for testing the functionality of the CVR, an ERASE switch to bulk erase the CVR recording, headset jack to listen to the audio as it is recorded, and a TEST indicator lamp. The CAM is located on the overhead panel and records the sounds and conversations that take place on the flight deck, including audio output from the cockpit speaker. The impact switch will open and remove power to the CVR if the aircraft goes into a rapid deceleration in excess on 2 g's. The components are integrated as shown in Figure 3.
